RE: North Bend Rail Trail Assessment

**North Bend Rail Trail Assessment**  
**WV TRAIL**  
**May 2026**  
**Executive Summary**

## **North Bend Rail Trail Assessment**

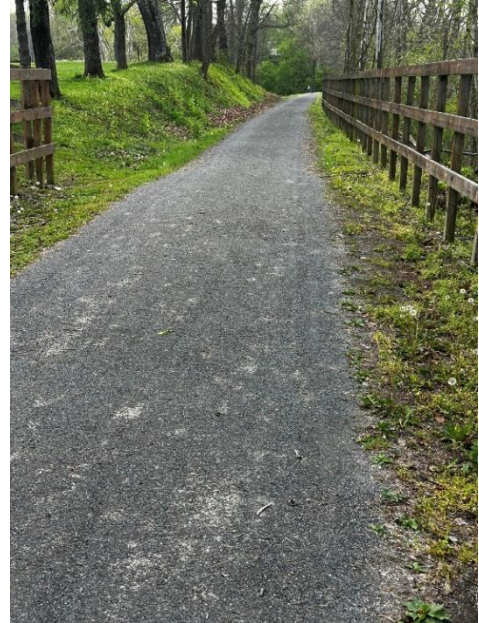
My tour of the trail was in a state vehicle and from that perspective, most of the trail seemed to be “acceptable”. It is my opinion that most visitor complaints are around expectations. The photo on the left is a general

representation of the NBRT. There are many notable exceptions especially at tunnels, crossings, culverts, damaged areas and other areas. The photograph on the right is the Harrison South Rail Trail which represents what most users expect in a government managed rail trail.

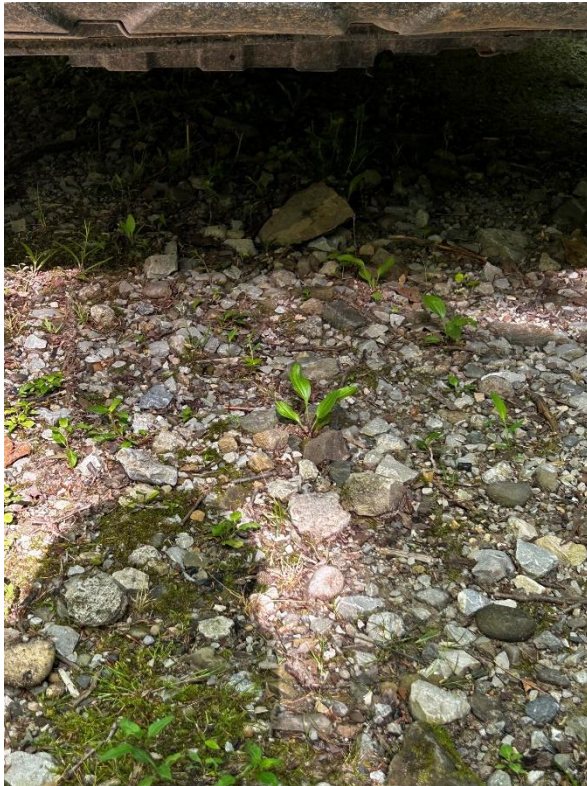
This picture represents damage by the fiber install. The contractor dug holes, placed the overburden consisting of ballast and all forms of stone onto the finished surface and then swept the material into the hole without regard to the finished surface of the trail. The only solution here is to resurface the trail with proper materials.

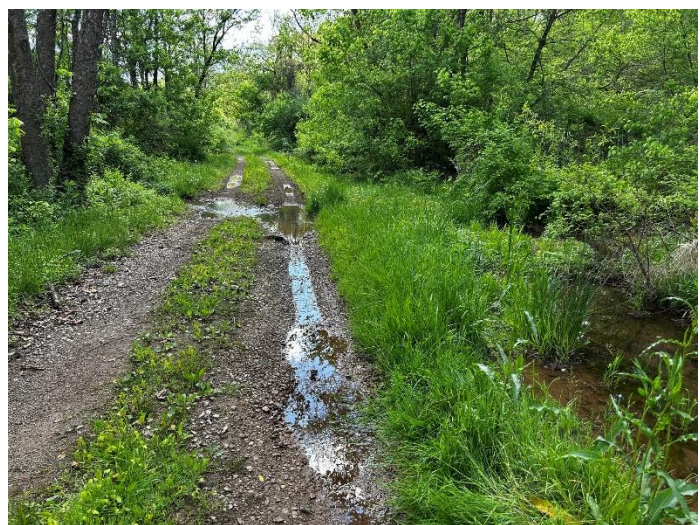
properties. These photographs show water that's been diverted from the public road to the trail. There are 9 sites directly resulting from the DOH directing water onto the trail from the nearby public highway. These photographs, located at Duckworth, is an excellent example of how the DOH can and should assist with the condition concerns of the NBRT. Unfortunately, attempts by Superintendent Elliott to have this addressed have gone unanswered.

- Managing water from public highways away from the trail. If no solution exists other than directing water onto the trail corridor, then assist with the installation and maintenance of ditches and culverts for those sites.
- Repair to ditches at public road crossings to remove the hazard for trail users.
- Formal agreements with the DOH for the unsanctioned use of the trail and expectations of the trail standards and maintenance following the project.

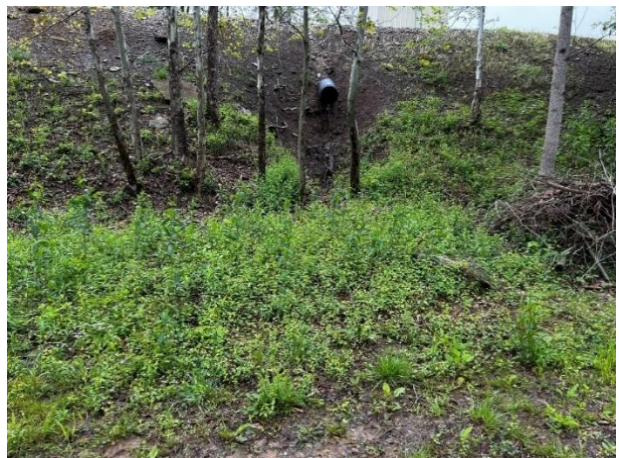
There are 6 sites where the private landowners divert water from adjacent development to the trail. This picture is an example in Ellenboro where the developer

created a drain that is pointed directly at the trail. The drainage should be changed or, if this is the only solution for draining the water from the site, the landowner should be required to continue the culvert and drainage system across and away from the trail.

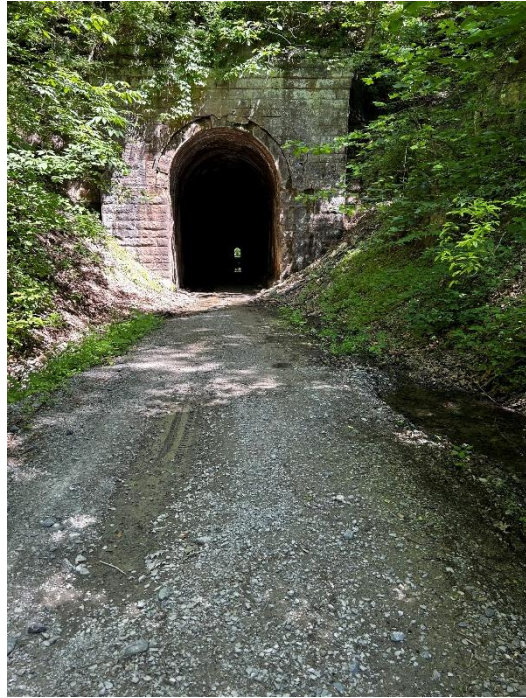
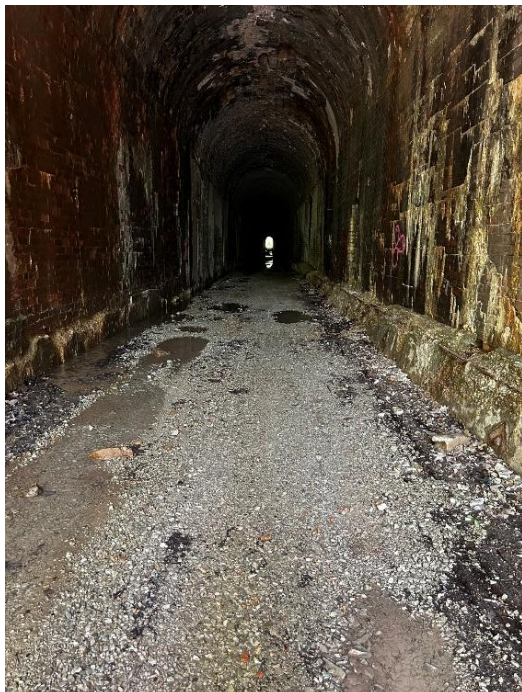
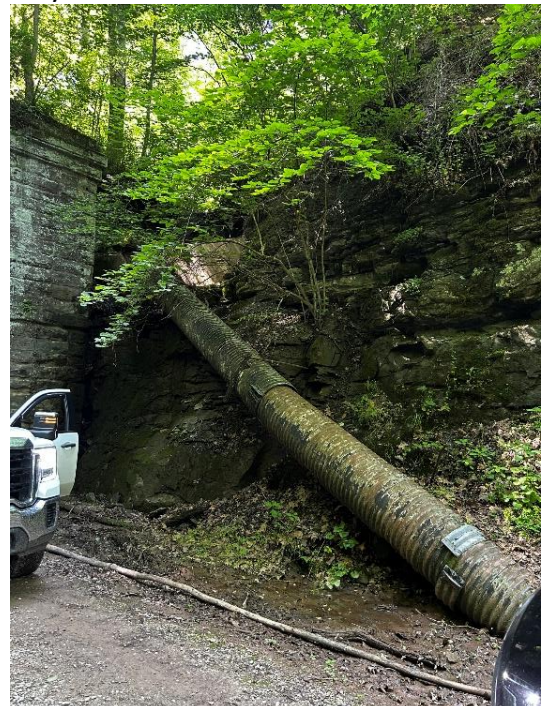
The primary issue that I observed with the tunnels is water management. Every tunnel appeared to have the same issues:

- The approaches to the tunnels are steep and narrow and are generally setting on bedrock. This creates significant challenges for water management.
- Since the approaches aren't drained well, this often causes water to set within the space or to back up into the tunnel and often flow through the tunnel. This then creates significant surface issue.
- Since tunnels are dark, the uneven surface and water in the tunnels is a safety concern.
- The water and surface management issue is exacerbated by the fiber install, who used the gutter on 1 side or the middle of the tunnel to install the conduit.
- Almost all tunnel entries have significant erosion from the materials above and around the tunnel entrance supports that need removed.

The photograph on the left shows inside of a tunnel. The photograph on the right shows attempts by the railroad decades ago to divert water from above the tunnel to ditches created along the cut. Water management has always been and always will be a matter at tunnels.

- The tunnel approaches need to have eroded materials hauled away
- The ditch lines outside the tunnels reestablished so water can drain away from the tunnels
- The gutters re-established in the tunnel
- Then surfacing along the approaches and inside the tunnels to raise the elevation of the trail surface to further create a gutter and water channel.

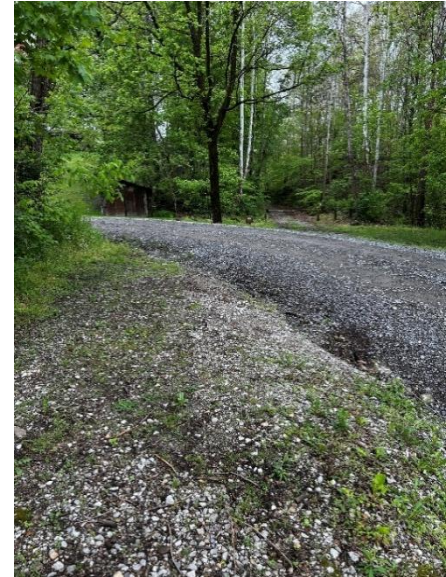
This picture represents an issue found at some public crossings. A deep ditch created by the DOH to manage water for the public road, must be navigated by unknowing trail users, often requiring getting off a bike and walking over the deep ditch. These needs repaired, however, attempts to work with local DOH offices to address these have not been successful.

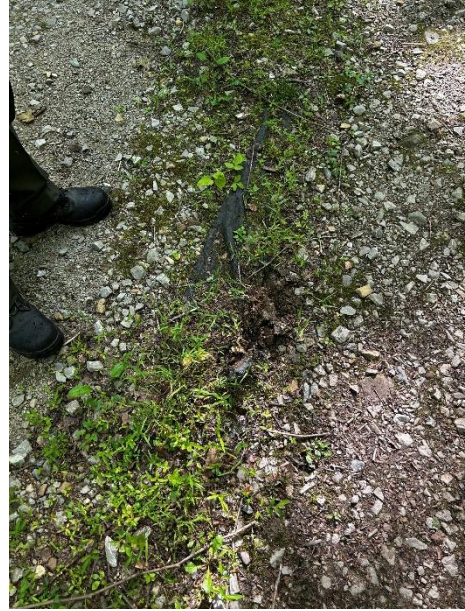
- Much of the equipment used for installation was too wide for the trail gate barriers. In order to pass through gate openings, the posts were either pushed outward by equipment or simply removed and not reinstalled. This made many of the gated

crossings now unable to be secured. The superintendent also reports that many of the locks for the gates were lost by the contractor.

We recommend a review of the contract with the fiber company and to assure that existing repairs are made for the trail prior to any further work or contract extensions. The contractor should be required to be held responsible for repairs and likely a more formal engagement on the punch list, expectations and outcomes.
